THE UNITED STATES
STRATEGIC BOMBING SURVEY

THE EFFECTS
OF
THE ATOMIC BOMB
ON
HIROSHIMA, JAPAN

Volume III

Physical Damage Division

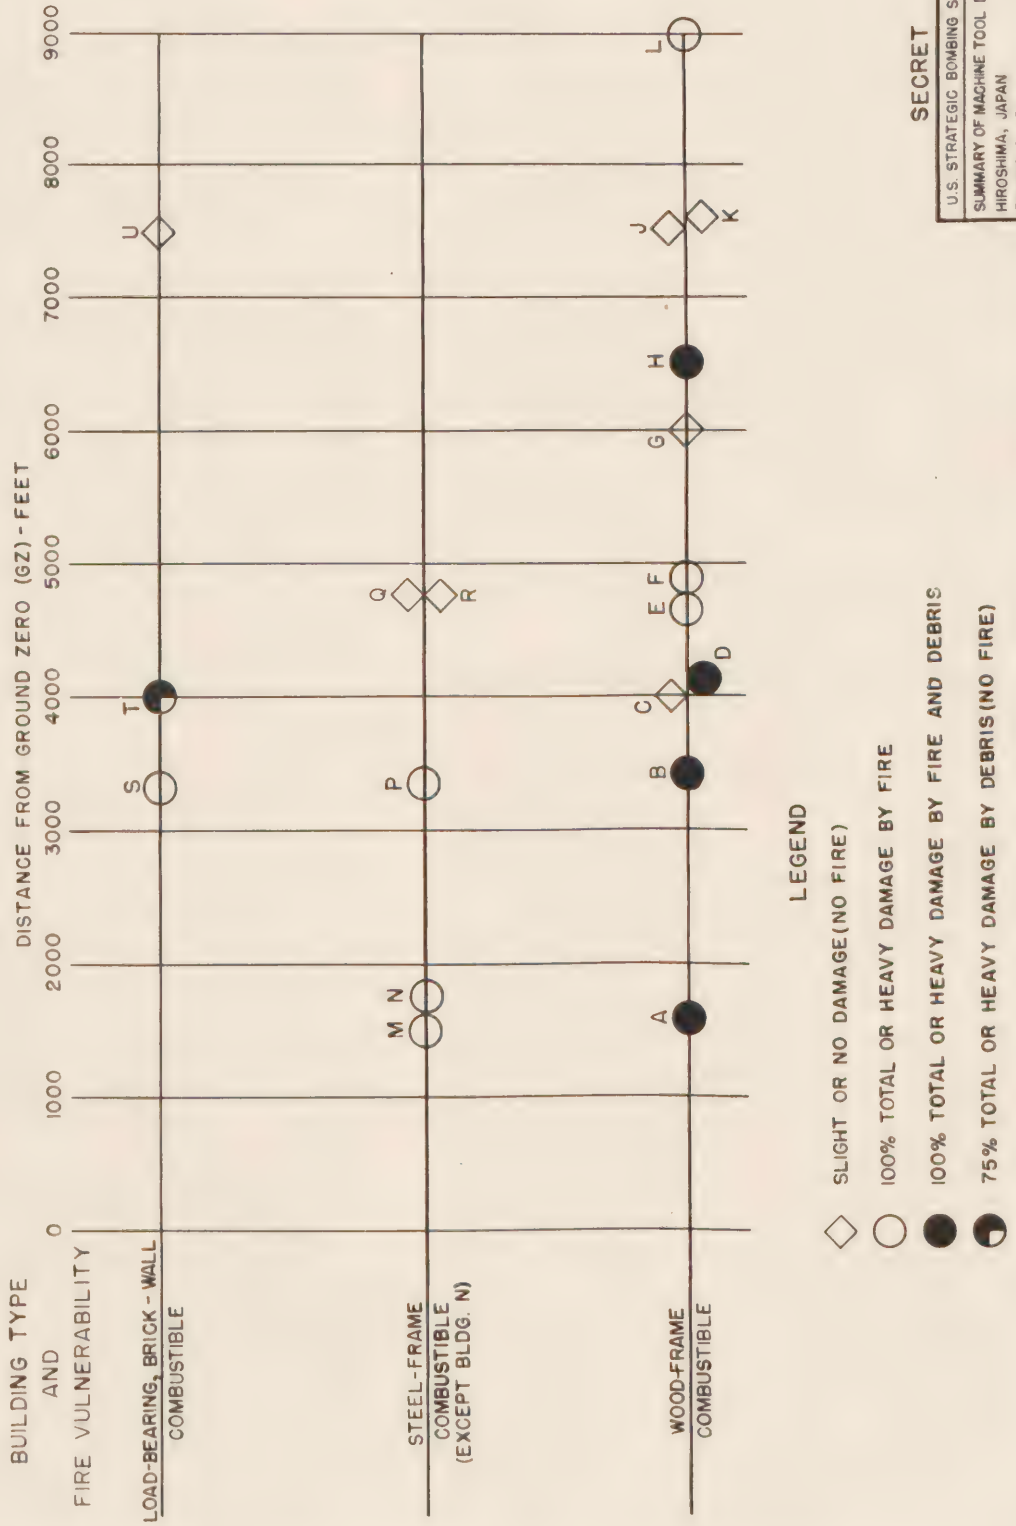
GRAPHIC SUMMARY OF CAUSE AND EXTENT OF DAMAGE TO MACHINE TOOLS

of direct damage by blast were observed, although a few cases of slight damage were attributable to displacement of overhead shafting and belting. In Table 1, all damage attributable to debris has been recorded, but damage caused by subsequent fire and weather effects has been recorded only when the damage was more severe than the category of damage by debris. For example, when machines which were heavily damaged by debris were subsequently heavily damaged by fire, but not totally damaged, the damage was tabulated in the heavy-damage-by-debris category; and when machines which were heavily damaged by fire were subsequently slightly or heavily damaged by exposure to weather, the damage was tabulated in the heavy-damage-by-fire category. The high-explosive vulnerability of all buildings was V4 (reference tables) since all were one-story, shed-type structures and the area of each, with the exception of one, was less than 10,000 square feet. The relationship between machine-tool damage and building structural and fire damage is summarized graphically in Figure 3.

mass distortion of the steel frames without tearing loose heavy structural members, and wall- and roof-sheathing debris was too light to cause more than slight damage, and then only to machine tools in buildings relatively close to GZ. A few machine tools were partly overturned by mass movement of building frames (Photos 15 and 16). Forty-two percent of the total floor area of the five steel-frame buildings was structurally damaged by blast as compared to 28 percent serious damage to machine tools, none of which was caused by debris (Fig. 3).

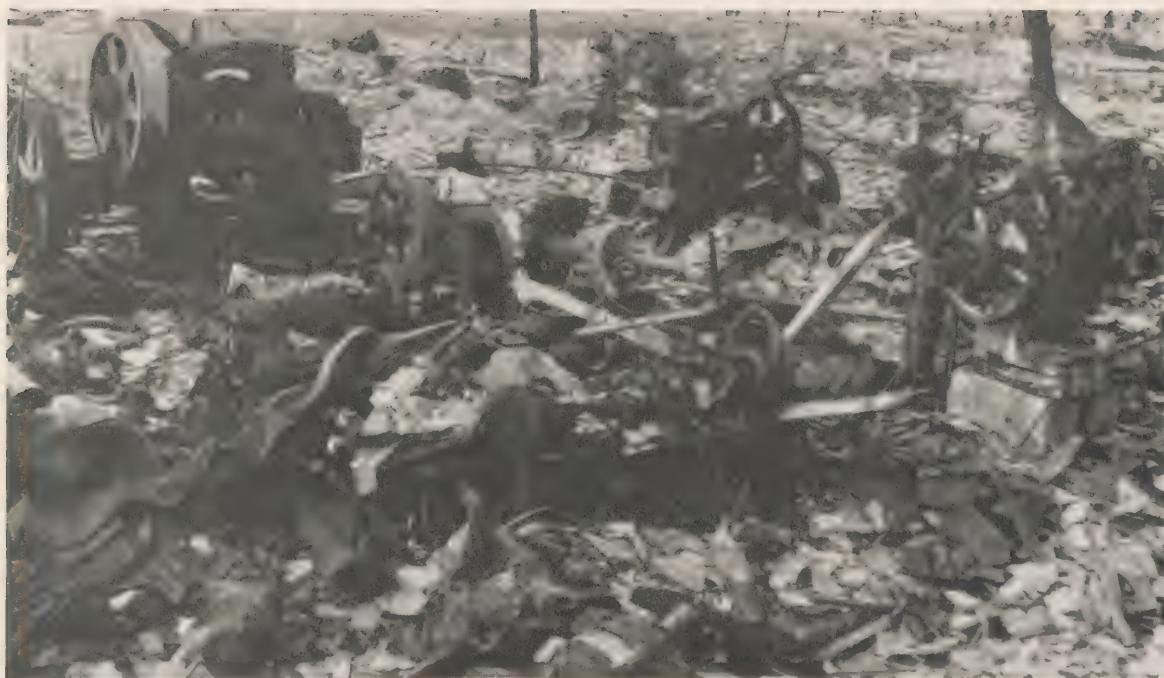
PHOTO 1-XI. Building A, 1,600 feet west of GZ, looking northwest. A wood-frame, light-engineering shop destroyed by blast. Debris broke casting of shear at left but casting was weak, having been cracked and welded previously. Fire burned combustible debris and seriously damaged remainder of machine tools.

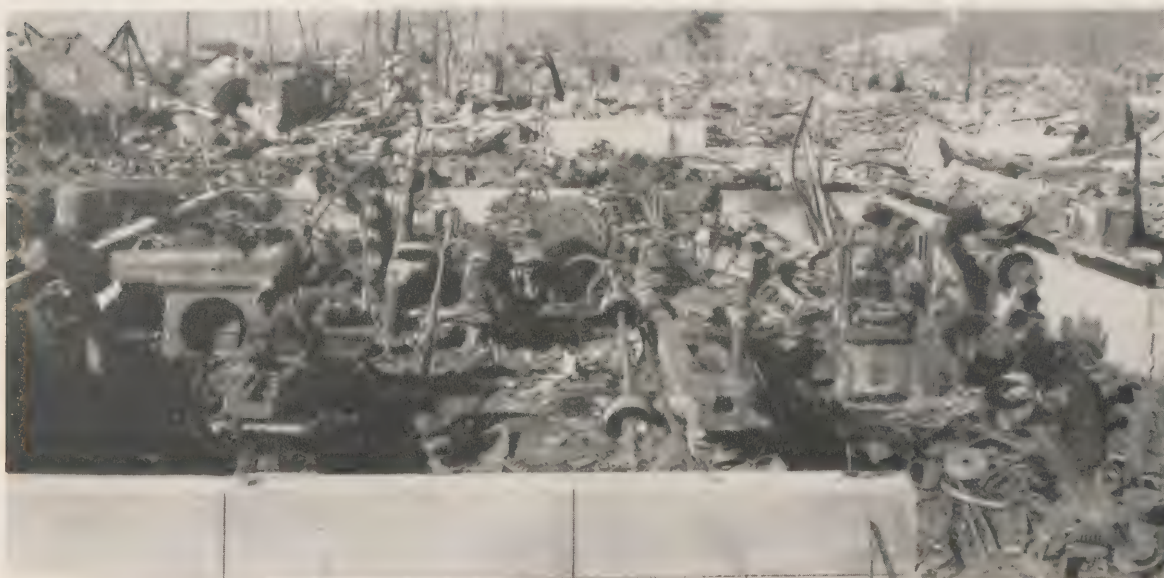
PHOTO 2-XI. Building B, 3,400 feet northwest of GZ, looking west. A congested, wood-frame, light-engineering shop totally damaged by blast. All machine tools seriously damaged, caused mainly by fire which burned debris. Note partly overturned drill press and overhead line shafting thrown over wall away from blast.

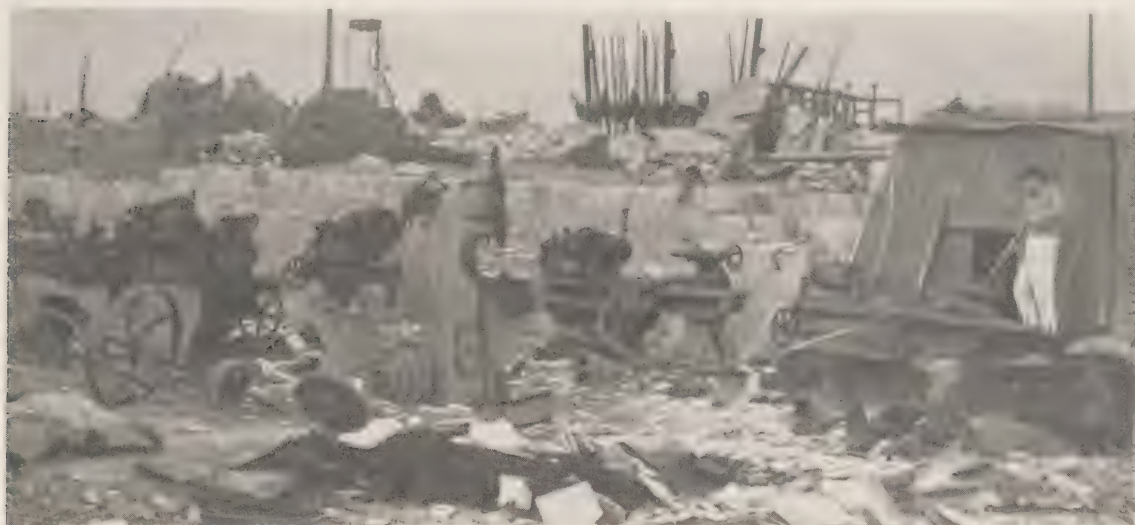
PHOTO 6-XI. Building E, 4,700 feet southwest of GZ, looking northwest. A wood-frame, light-engineering shop destroyed by blast. Serious damage entirely by fire which burned combustible debris. Note milling machine at right overturned when blast collapsed building. Press in center partly overturned in same manner.

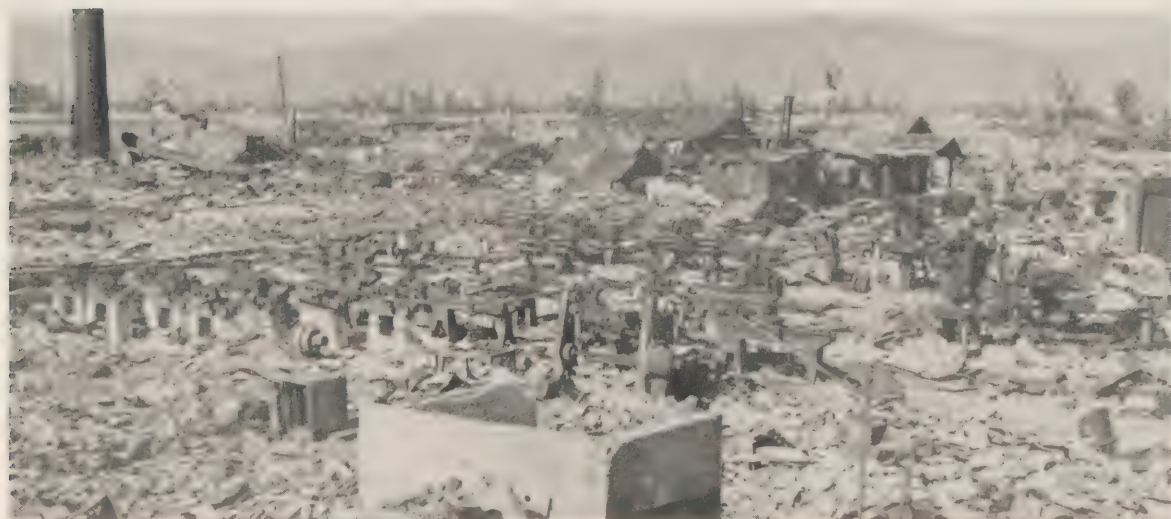
PHOTO 8-XI. Building H, 6,500 feet southeast of GZ, looking northwest. A wood-frame, light-engineering shop structurally damaged by blast. Ensuing fire caused most of serious damage to machine tools. Note cracked concrete base of small lathe at left.

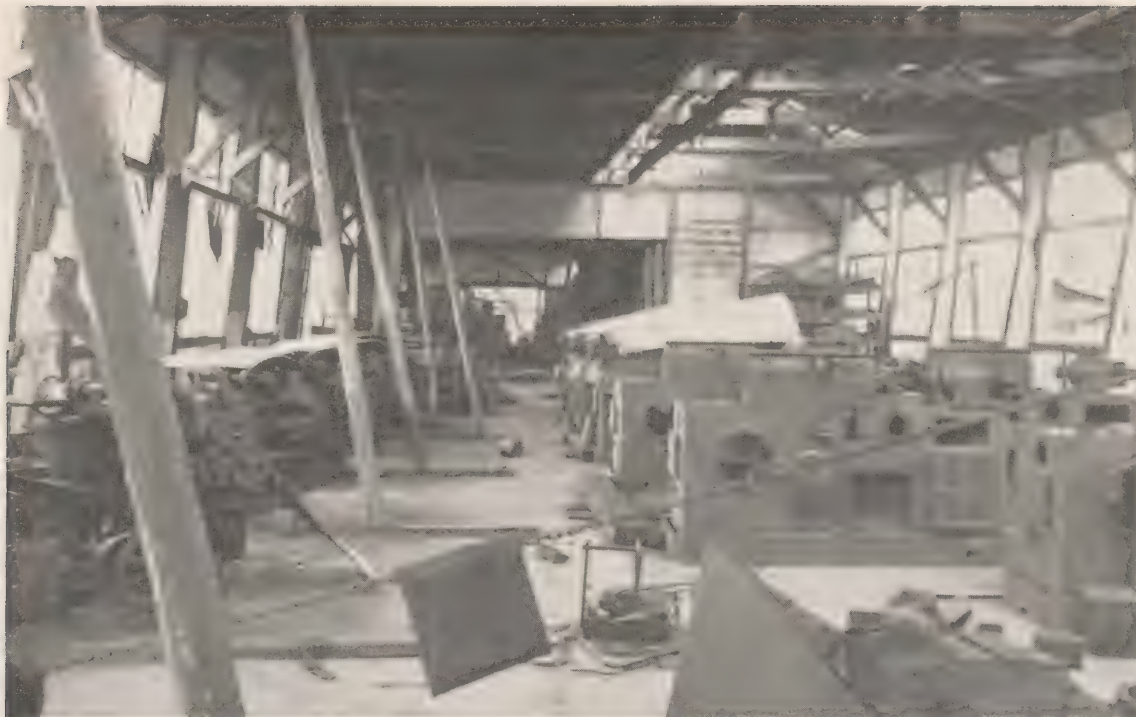
c. Weather. Most machine tools in structurally damaged and some in superficially damaged wood-frame buildings were exposed to the elements and in most cases no attempt was made to protect them, except that a few machines were protected with grease or sheets of corrugated iron (Photos 9 to 11). Rusting apparently was more severe on machine tools which had been exposed to fire, probably because all lubricants and paint had been burned off. Exposure to weather increased the degree of heavy damage to machine tools in burned buildings, and caused slight damage in blast-damaged buildings.

PHOTO 11-XI. Building J, 7,500 feet south of GZ, looking east. A wood-frame machine shop superficially damaged by blast (no fire). Some machine tools slightly damaged by weather. Note corrugated-iron sheets on machines.

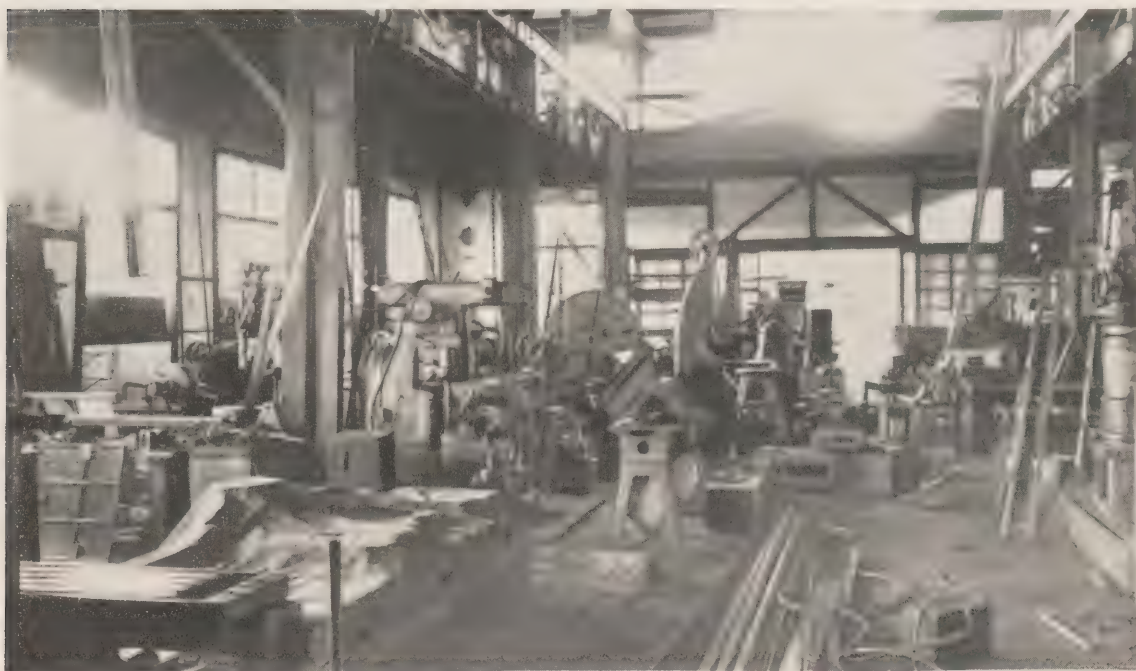
PHOTO 12-XI. Building K, 7,600 feet south of GZ, looking east. A wood-frame machine shop practically undamaged by blast (no fire). No damage to machine tools. Note tarpaulin over equipment at left.

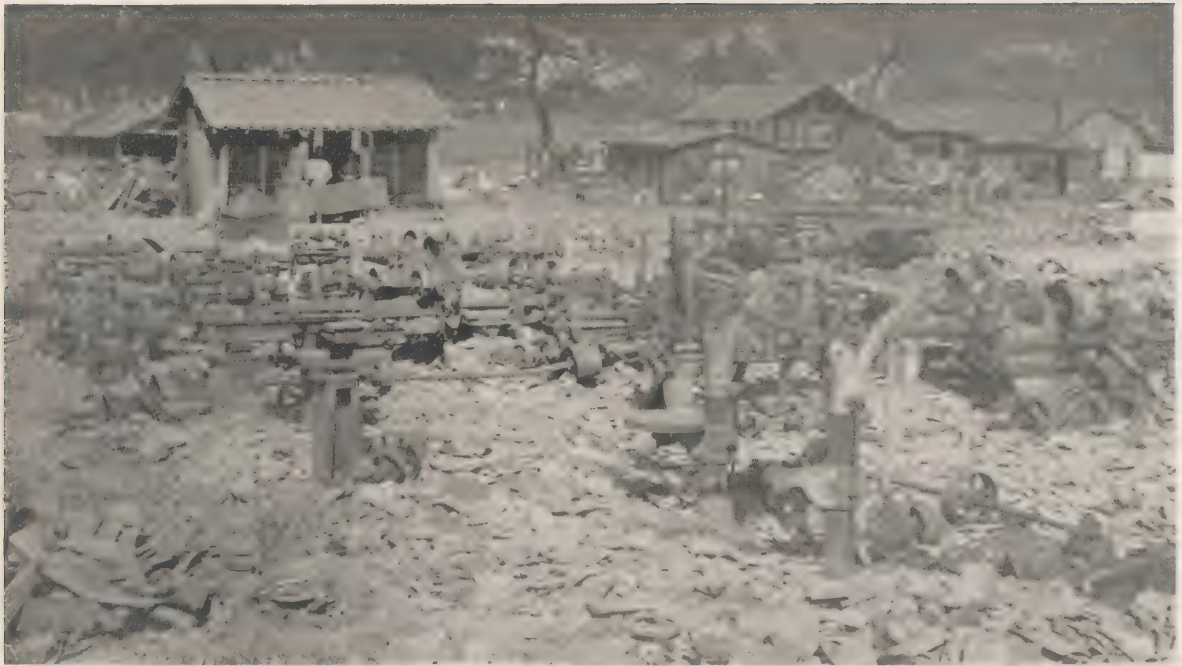
PHOTO 13-XI. Building L, 9,000 feet east of GZ, looking north. A wood-frame, light-engineering shop destroyed by fire near edge of a completely burned, congested area. Serious fire damage to all machine tools. Note machines unprotected from weather.

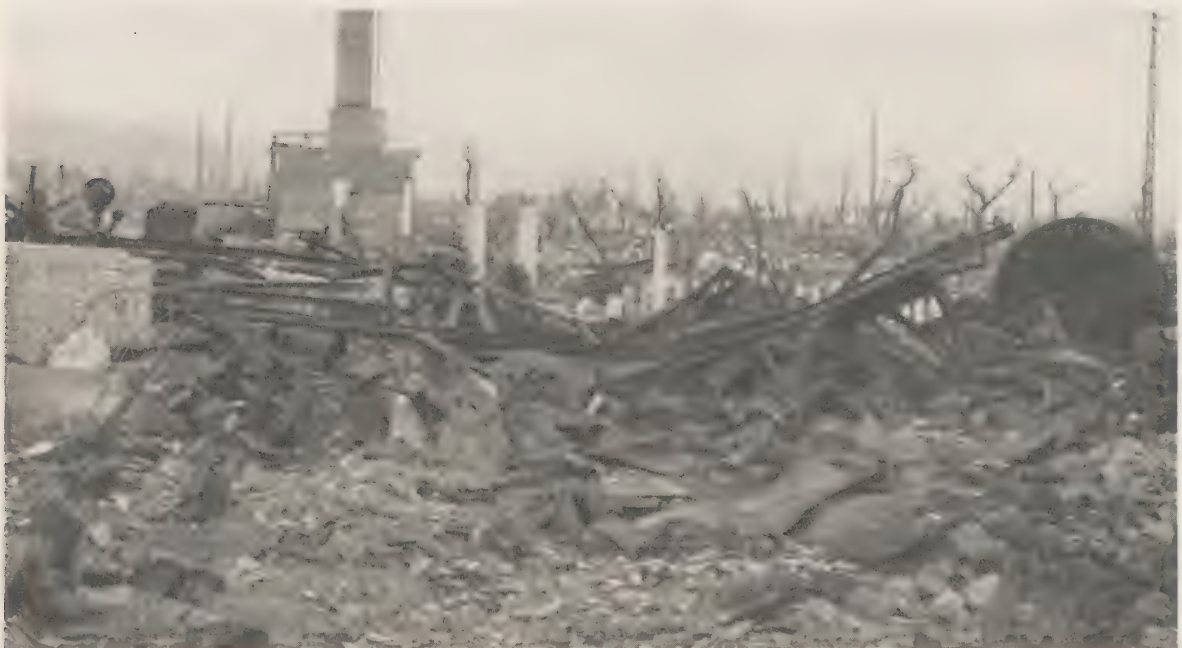
b. Fire. Fire caused all serious damage to machine tools in the five steel-frame buildings, four of which were combustible and the other noncombustible. Three of these buildings, including the noncombustible one, were completely burned out (Photos 14–17). All machine tools were totally or heavily damaged in the burned buildings, the percentage of machine tools seriously damaged (28 percent) being equal to the percentage of floor area involved by fire (Fig. 3). Serious fire damage to machine tools resulted in the combustible buildings because floors and wall and roof sheathing were combustible; combustible debris was blown onto and around the machines; some of the contents were combustible; and the buildings were located in congested, combustible areas which were completely burned over. The machine tools in the noncombustible building were heavily damaged because the floor and some contents were combustible and exposing buildings burned close by on two sides.

PHOTO 14-XI. Building M, 1,500 feet west of GZ, looking north. A steel-frame, combustible machine shop structurally damaged by blast. Slight damage to machine tools by debris, but serious damage to all by fire. Entire surrounding congested area burned over.

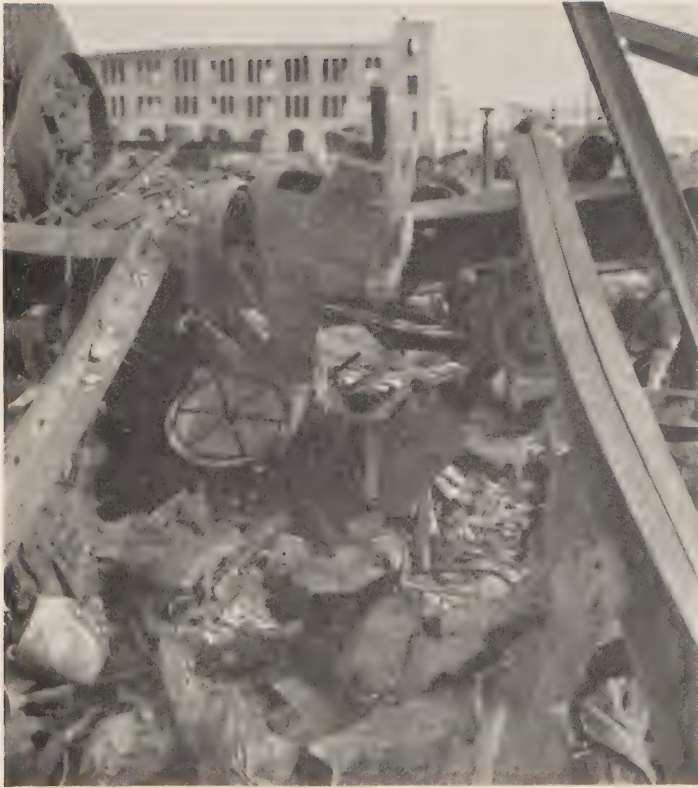
PHOTO 15-XI. Building M, 1,500 feet west of GZ, looking east. Shows drill press partly overturned and small casting broken at the top by mass distortion of steel frame of building. All machine tools seriously damaged by fire.

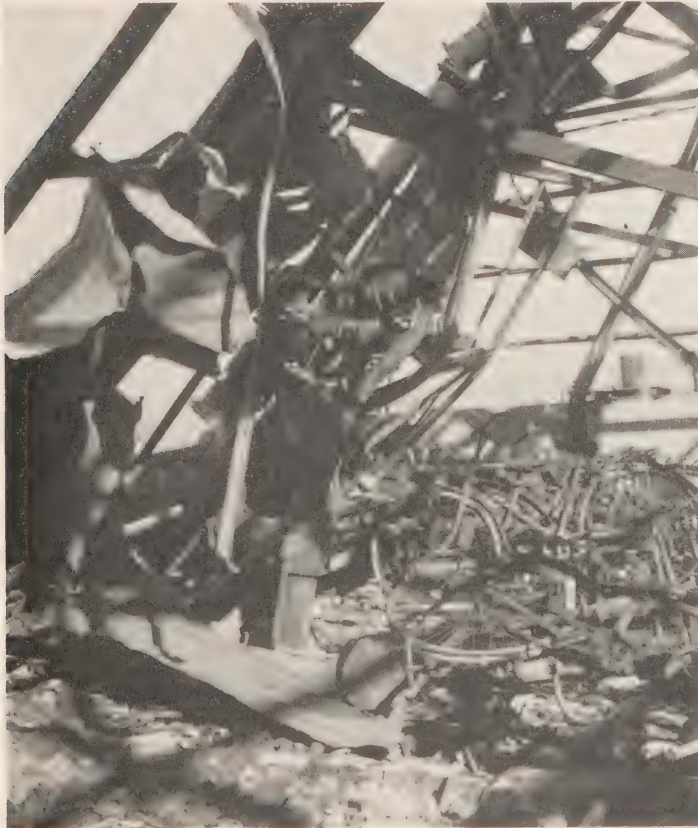
PHOTO 16-XI. Building N, 1,800 feet east of GZ, looking north. A steel-frame, noncombustible repair shop structurally damaged by blast. Drill press and lathe seriously damaged by fire in combustible floor and contents. Note rubber tires on bicycles burned.

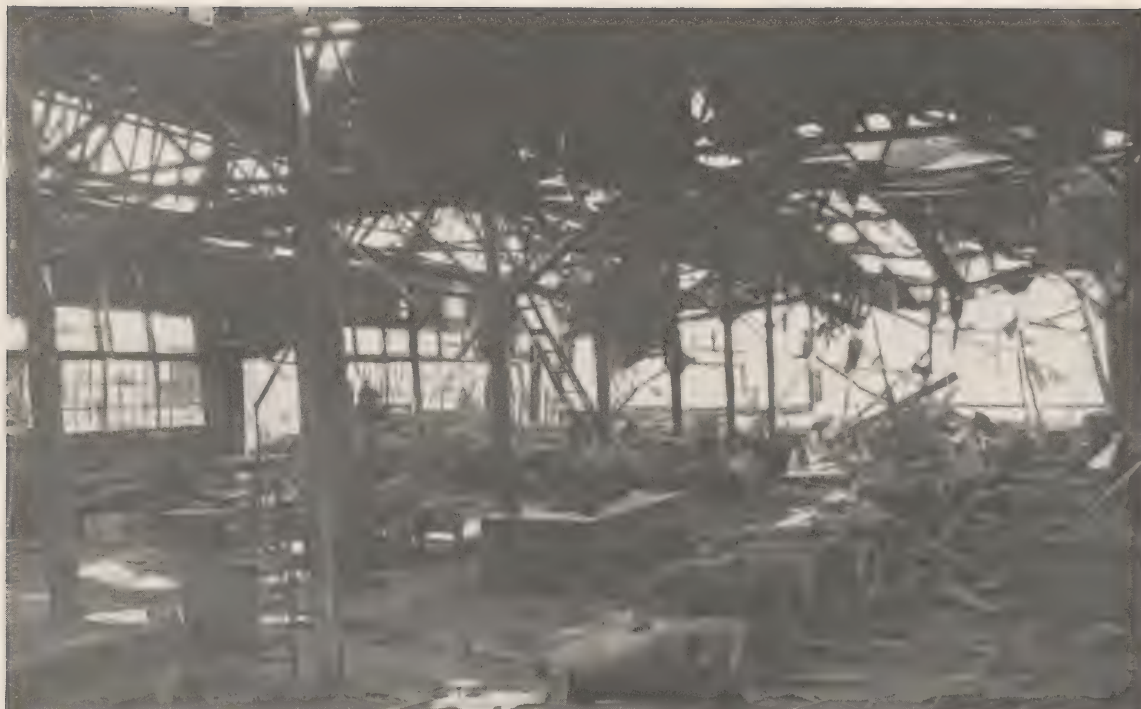
c. Weather. Exposure to weather was the cause of slight damage to machine tools in two steel-frame buildings which had no fire (Photos 18 and 19), and increased the degree of damage to machine tools which had been heavily damaged by fire. As in wood-frame buildings, rusting of machine tools was much more severe in buildings which had burned than in ones which had been only blast damaged. Machine tools in these buildings were not given a coating of grease or otherwise protected from weather after the attack.

PHOTO 18-XI. Building Q, 4,700 feet west of GZ, looking east. A steel-frame, combustible, heavy-engineering shop structurally damaged at east end by blast. No damage to machine tools by blast or debris. No fire.

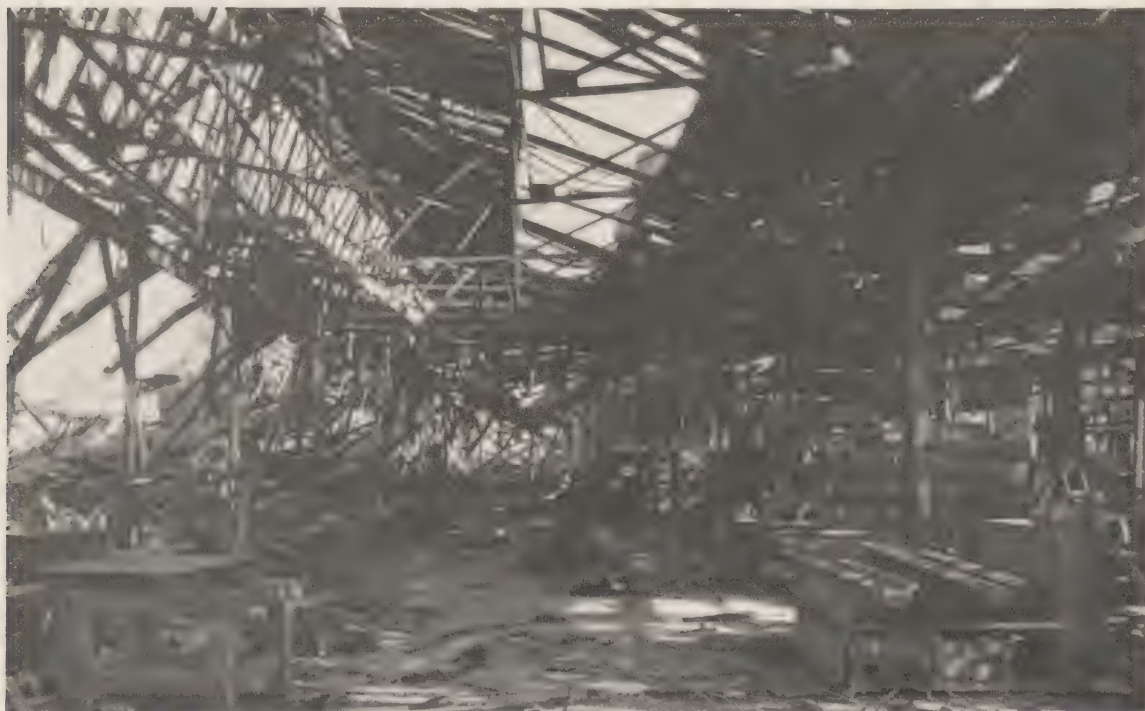
PHOTO 19-XI. Building R, 4,700 feet west of GZ, looking east. A steel-frame, combustible, heavy-engineering shop about one-half structurally damaged by blast. No damage to machine tools by blast or debris. No fire.

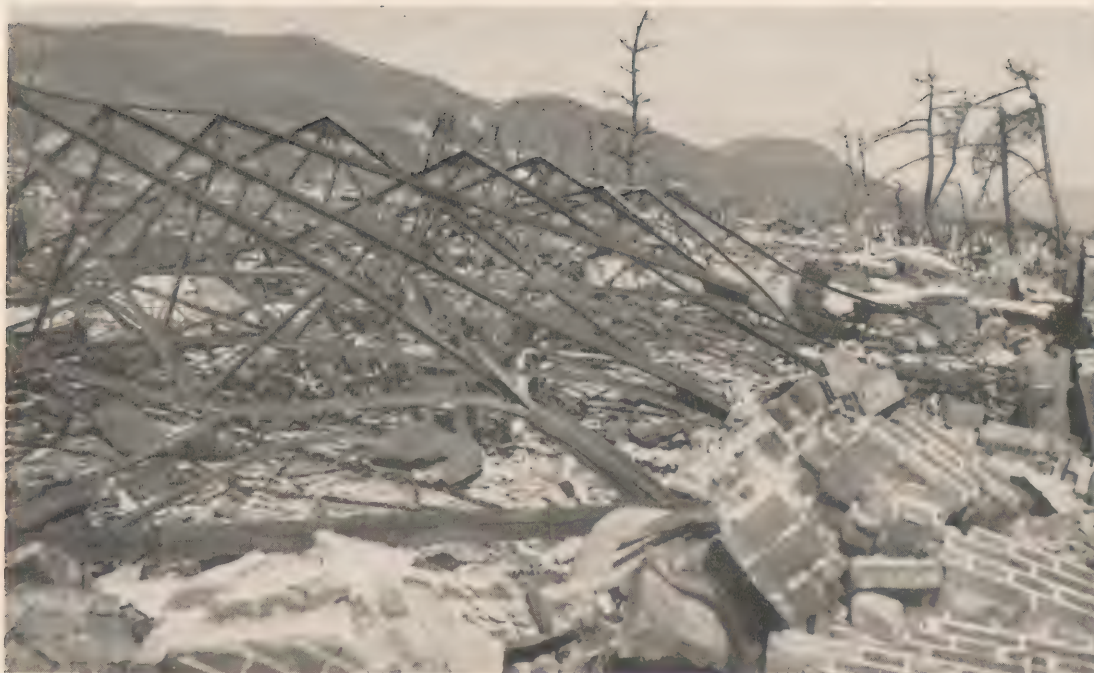
b. Fire. Only one of the three load-bearing, brick-wall buildings had fire. This building was completely burned out and all the machine tools were totally or heavily damaged by fire alone, although the building was 100 percent structurally damaged by blast (Photos 21 and 22). The reasons for the serious damage to machine tools by fire were that the roof was completely collapsed, placing the wood-sheathing debris close to the machine; some of the contents were combustible; and the building was located in a congested, combustible area which was completely burned over.

PHOTO 22-XI. Building S, 3,300 feet northwest of GZ, looking north. A load-bearing, brick-wall machine shop completely collapsed by blast. Walls at right collapsed into building, but no machine tools were located near it. Steel trusses came to rest on machines but apparently did not crash down because of lateral motion imparted by blast, and only slight damage resulted. Fire caused serious damage to all machine tools.

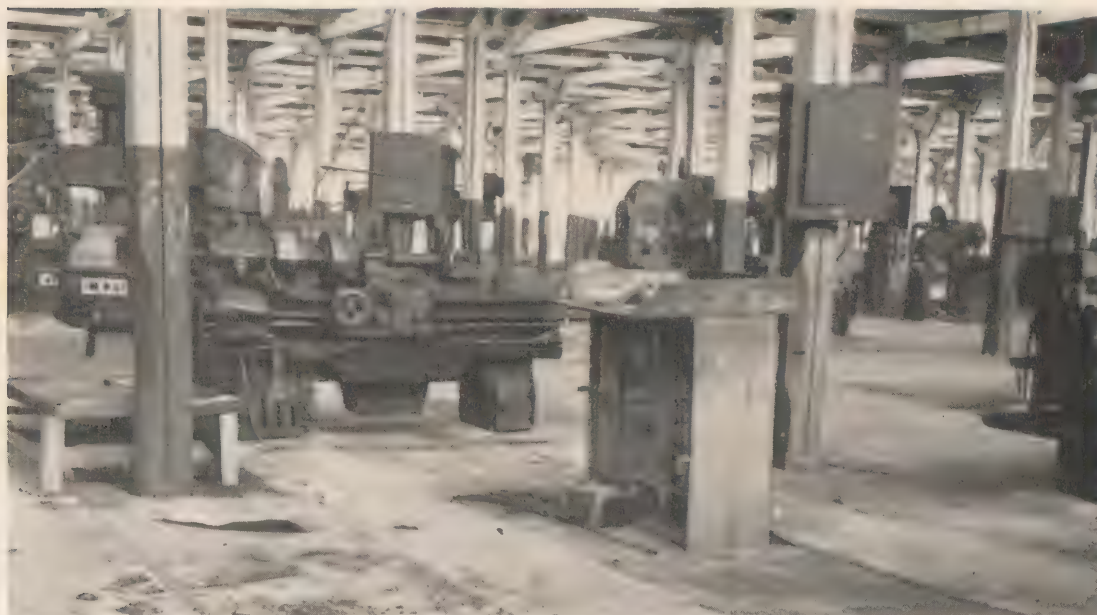
PHOTO 23-XI. Building U, 7,500 feet east of GZ, looking east. A load-bearing, brick-wall, combustible machine shop practically undamaged by blast. No damage to machines by blast or debris. No fire. Slight damage to few machine by weather.

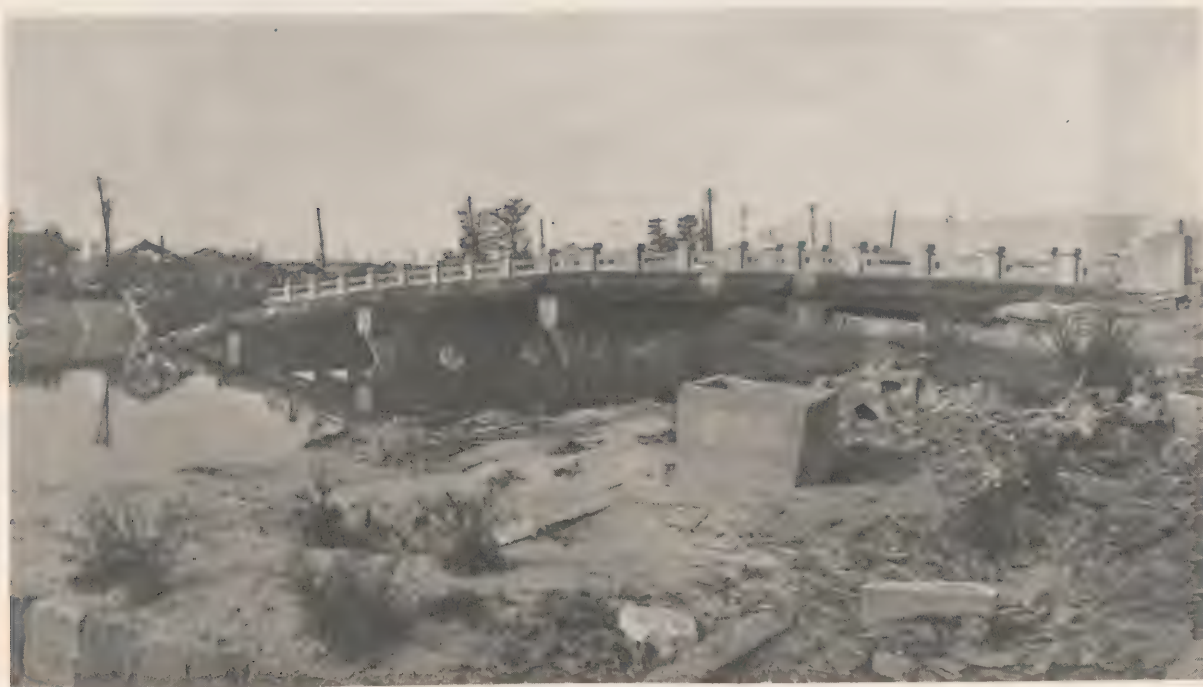
PHOTO 4 XII. Bridge 3. Looking west at flood-damaged, highway bridge over the Enko-Gawa. Water main carried by bents (7,130 feet to GZ, 7,390 feet to AZ).

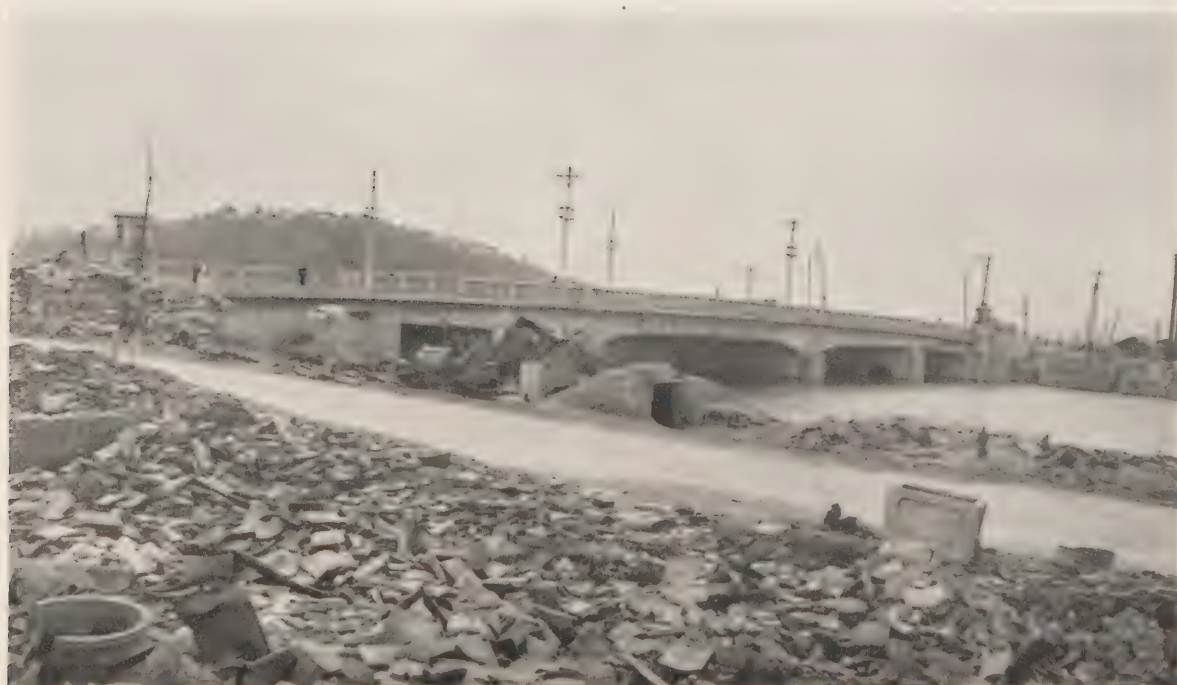
PHOTO 8-XII. Bridge 4. North elevation of reinforced-concrete bridge over the Enko-Gawa. Superficial blast damage at northeast corner railing (6,450 feet to GZ, 6,750 feet to AZ).

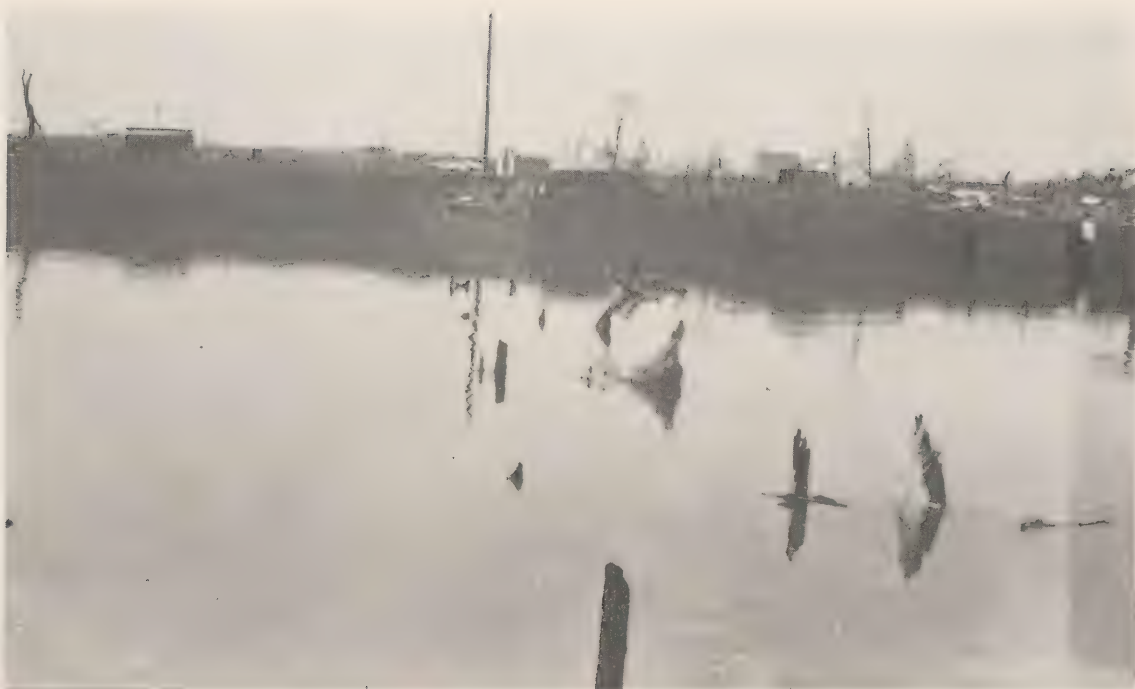
PHOTO 11-XII. Bridge 6. Looking south at remains of bridge over Enko-Gawa. Destroyed by blast and fire (5,370 feet to GZ, 5,730 feet to AZ).

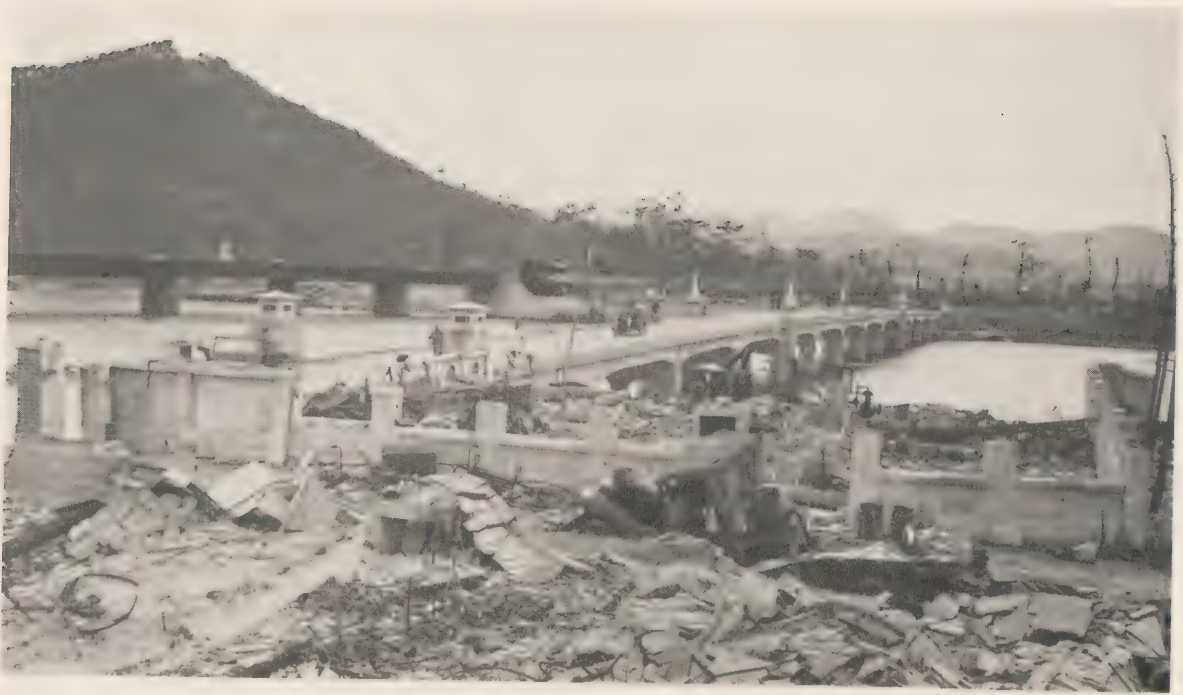
PHOTO 13-XII. Bridge 8. South elevation of bridge over Kyobashi-Gawa. Superficial blast damage to concrete railings (5,390 feet to GZ, 5,700 feet to AZ).

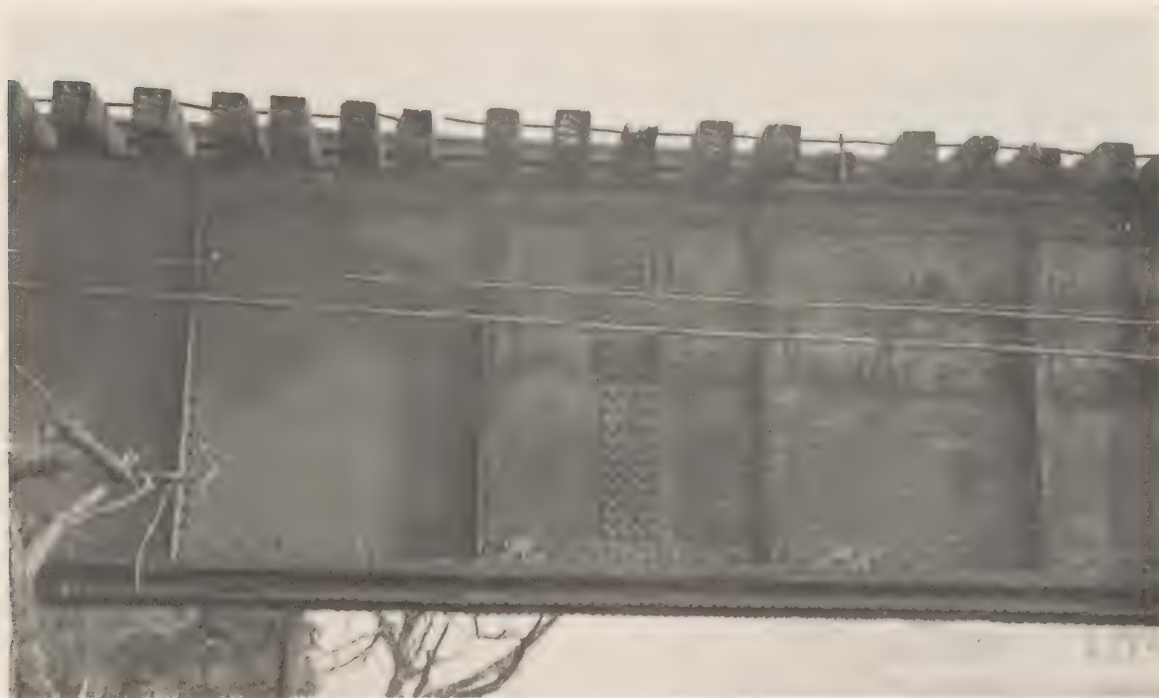
PHOTO 16-XII. Bridge 9. Paint on south elevation of steel girders discolored by exposure to bomb effects (5,730 feet to GZ, 6,050 feet to AZ).

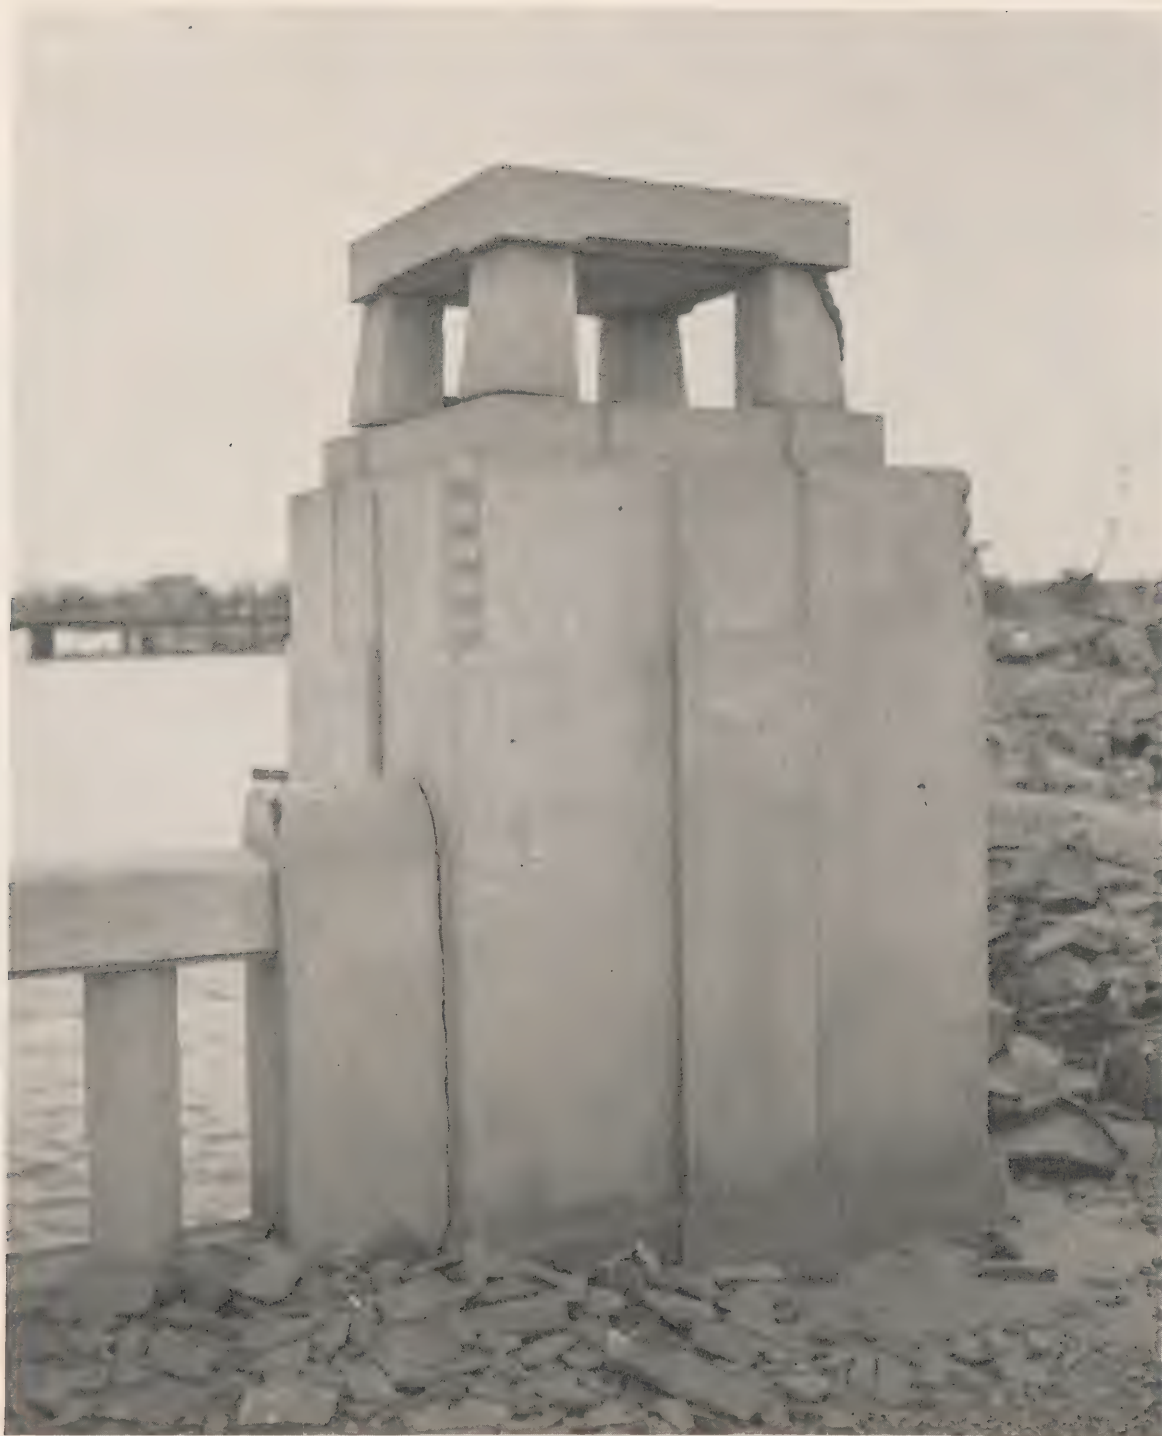
PHOTO 25-XII. Bridge 12. Ornamental stone post at southwest corner dislodged by blast (4,700 feet to GZ, 5,100 feet to AZ).

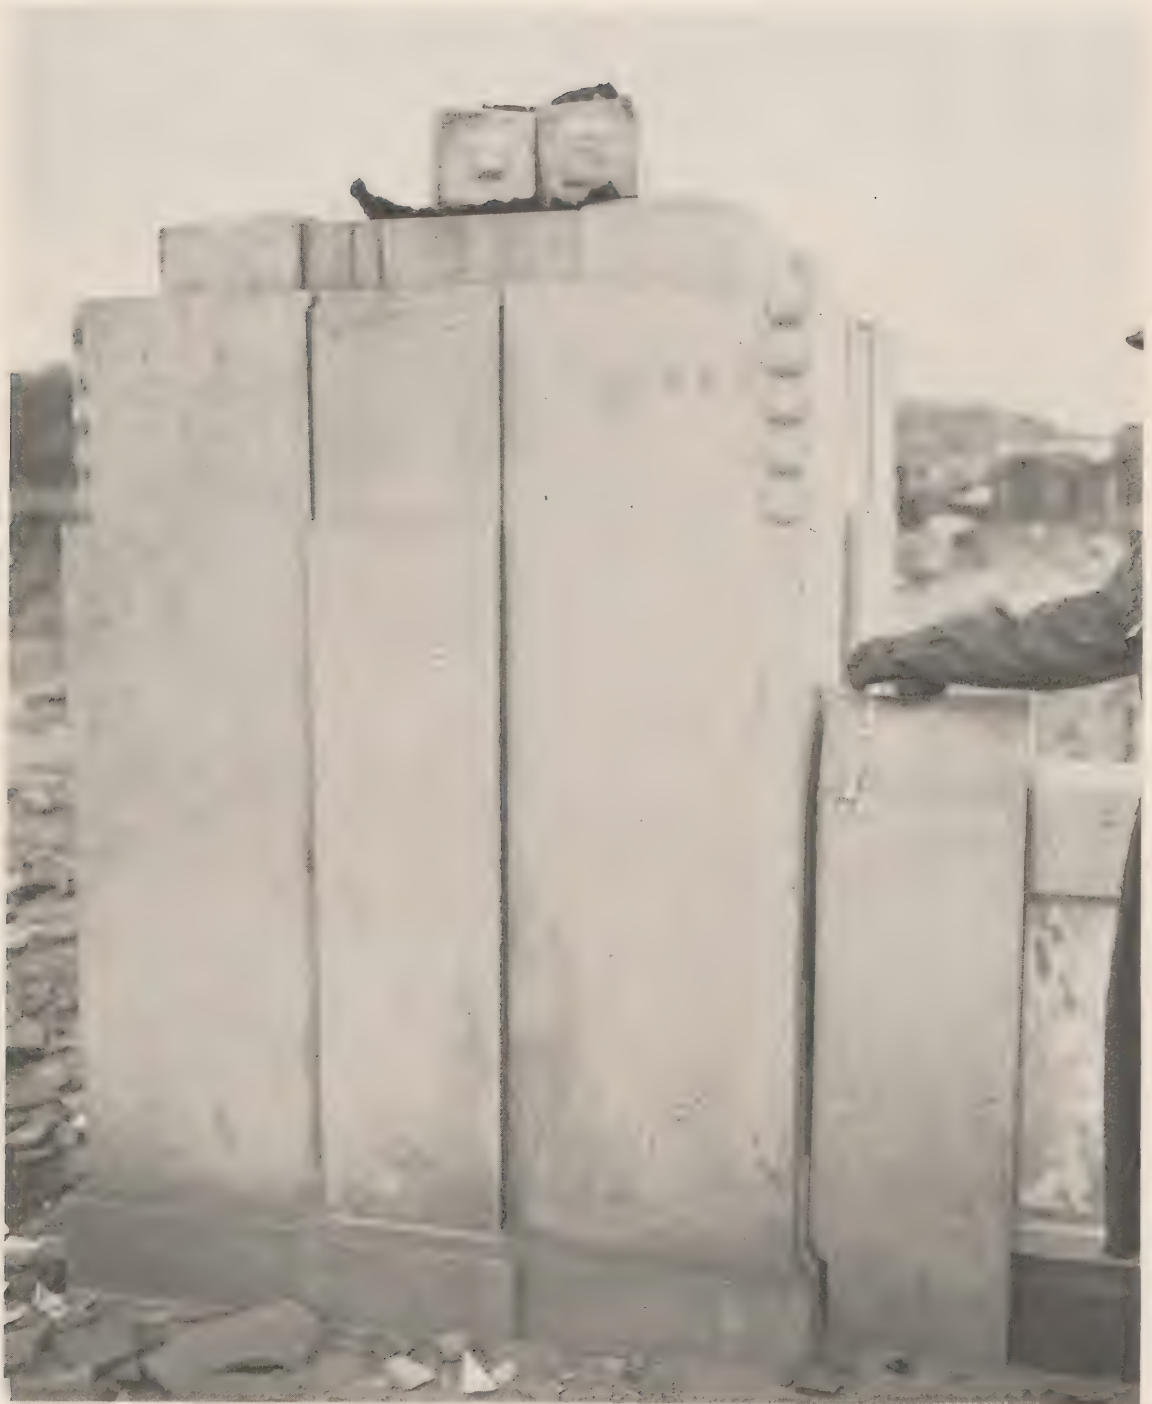
PHOTO 26-XII. Bridge 12. Ornamental stone post at southeast corner dislodged by blast (4,700 feet to GZ, 5,100 feet to AZ).

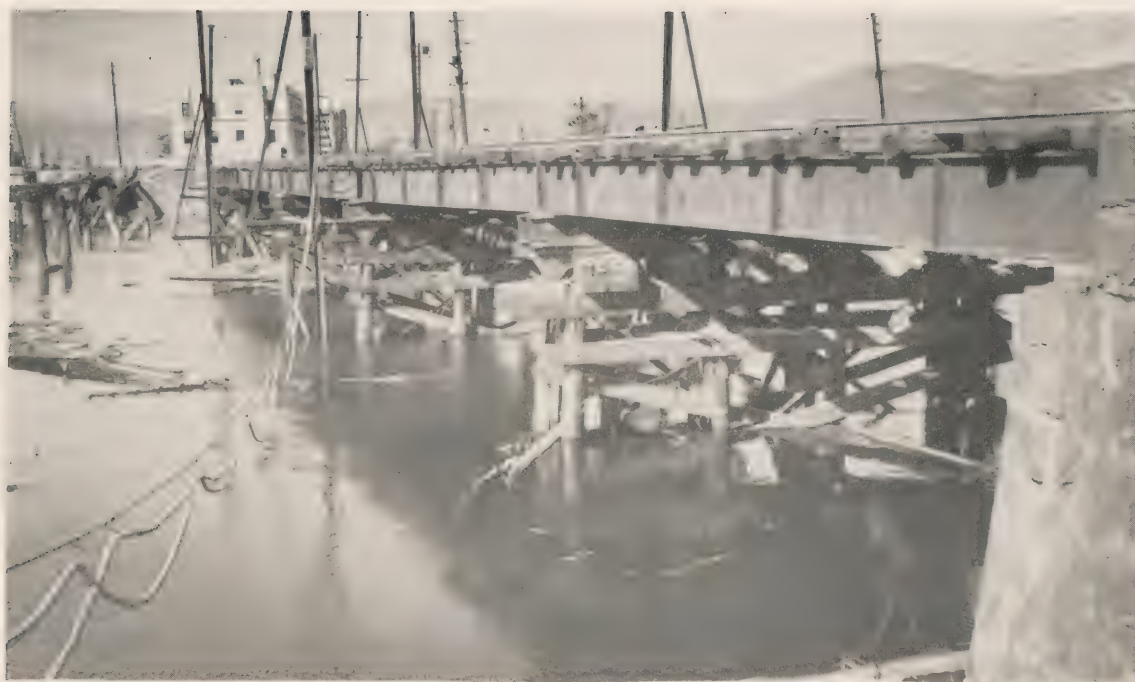
PHOTO 29-XII. Bridge 13. South elevation of trolley bridge.

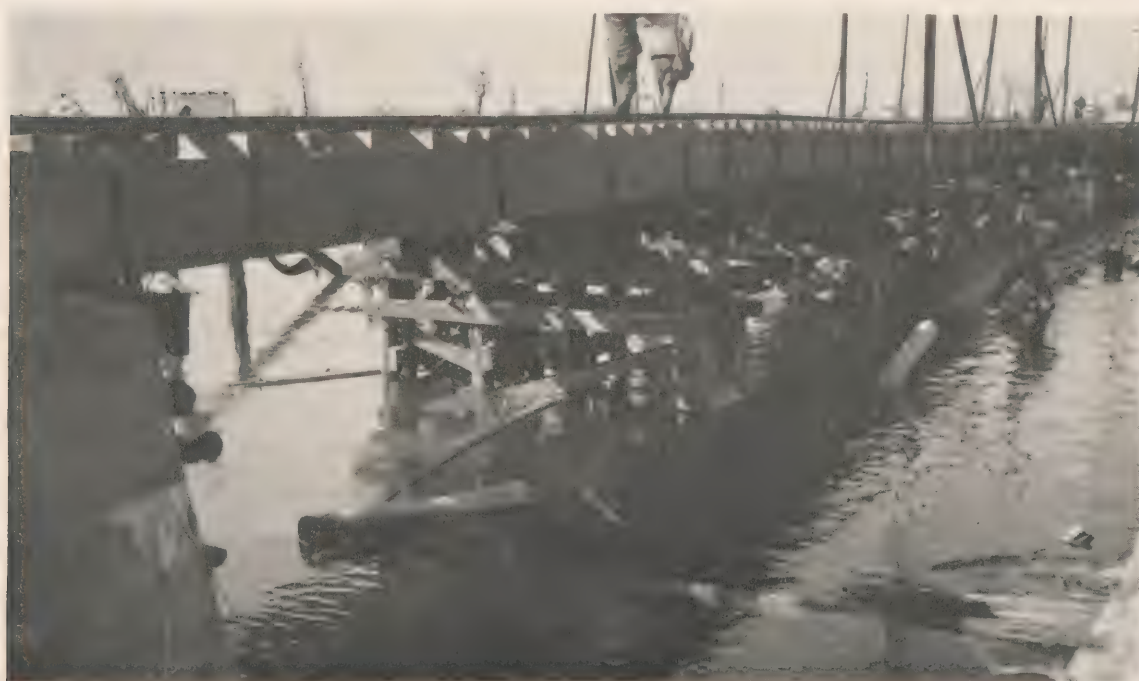
PHOTO 30-XII. Bridge 13. Flood and blast damage (4,670 feet to GZ, 5,080 feet to AZ) north elevation.
